# Monitoring of Targeted Works to Reduce Sediment Export to Waterways Entering Moreton Bay

**September 2012**

**On behalf of:** SEQ Catchments

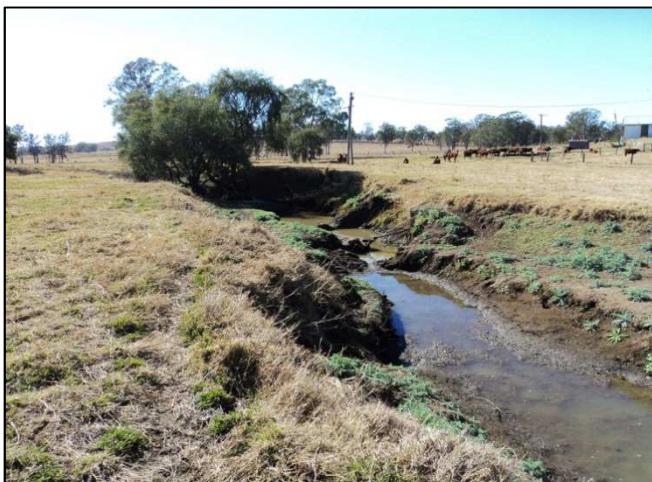
**Figure 3 - Gully erosion at the reinstated wetland**

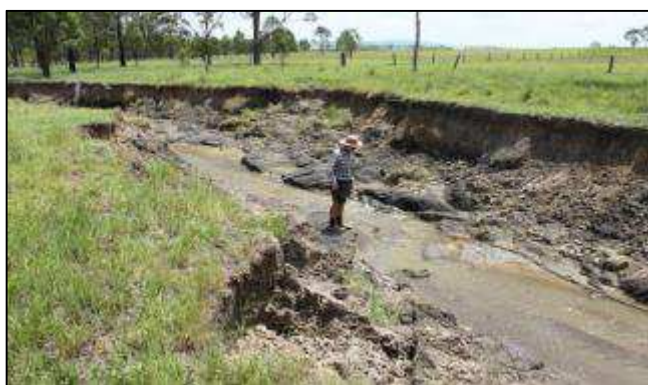
**Figure 11 - Gully erosion after construction of dams on the property**

Two dams have been constructed on the valley floor. The dams are holdings for a large upstream catchment (266 ha) that overflows frequently. Overland flows from the dam on the property, and stock access have contributed to highly erodible soils being exposed. The shoulders of the gully below the last dam are stable but discharge particularly to the north-west caused a long narrow gully to cut back from the adjacent property (Figure 11). This gully was 150 m long and contributed approximately 1764 m<sup>3</sup> of sediment (Table 4) further downstream.

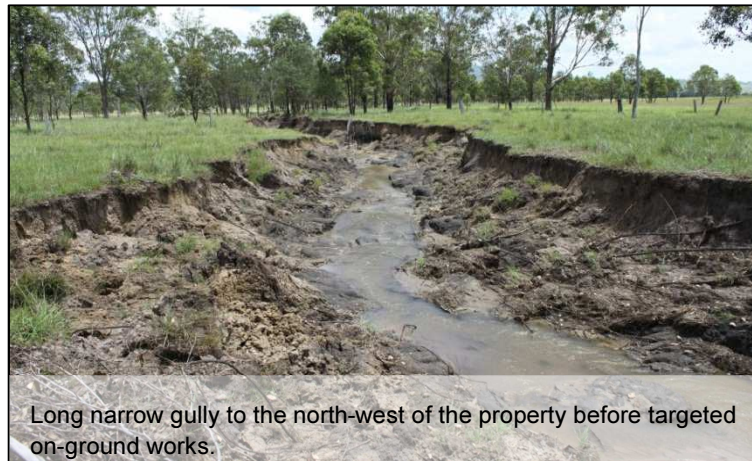
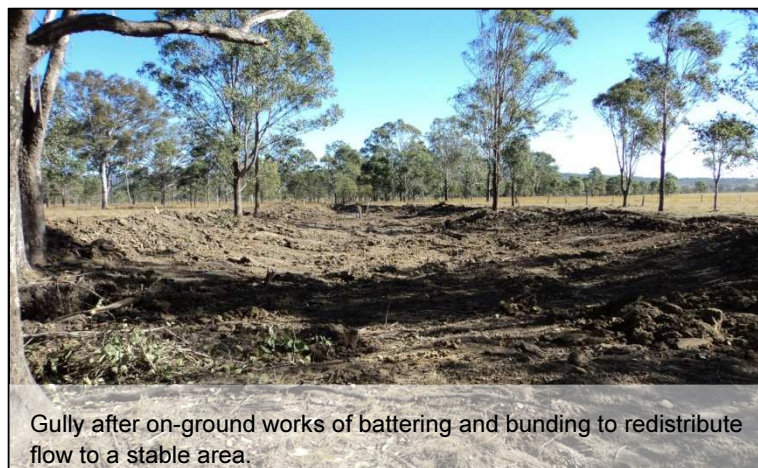
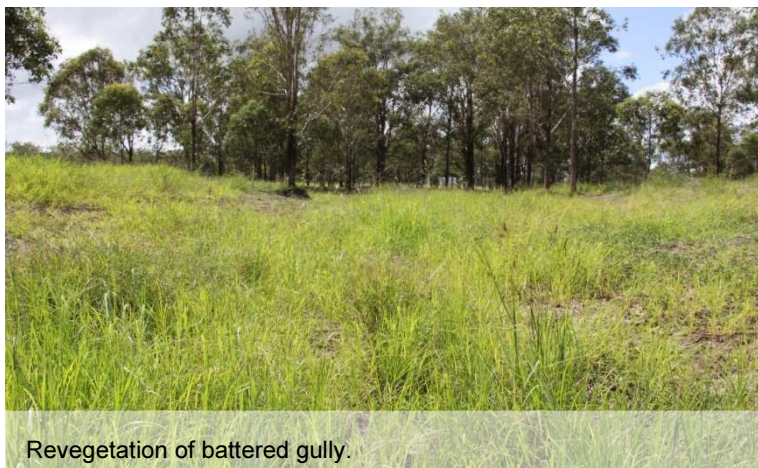
a) JUNE 2010

b) JUNE 2011

c) FEBRUARY 2012

Photographic surveys will allow the tracking of natural revegetation of the battered gully and the stability of the diversion area (Figure 15). These surveys will also enable the documentation of any weak spots that may appear in the new diversion path, hydrological changes and sediment deposition over the survey period.

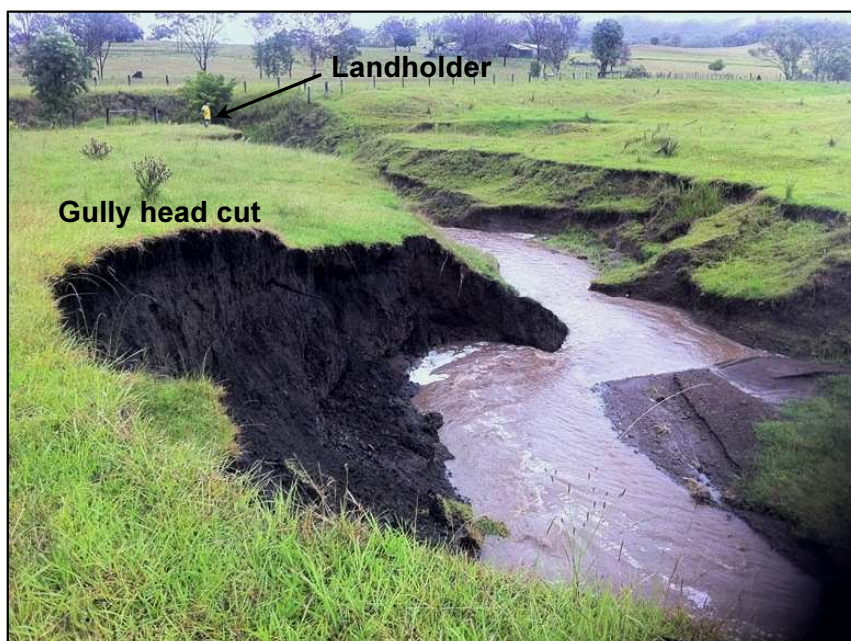
**Figure 16 - The major gully head cut which measured over five metres deep**

This gully system has three major head cuts that have retreated significantly in the six months from October 2010 to April 2011, with one head cut fall being over five metres (Figure 16). This, combined with a major bank slump retreating into valuable cultivation land, has contributed large volumes of sediment into the Bremer catchment and has the potential to contribute more.

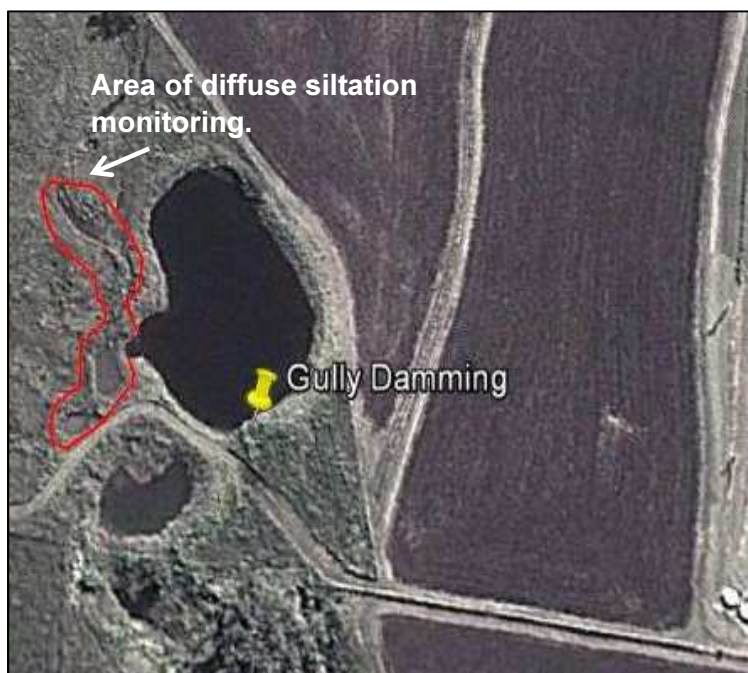
**Figure 17 - Diffuse siltation monitoring area at Site 3**

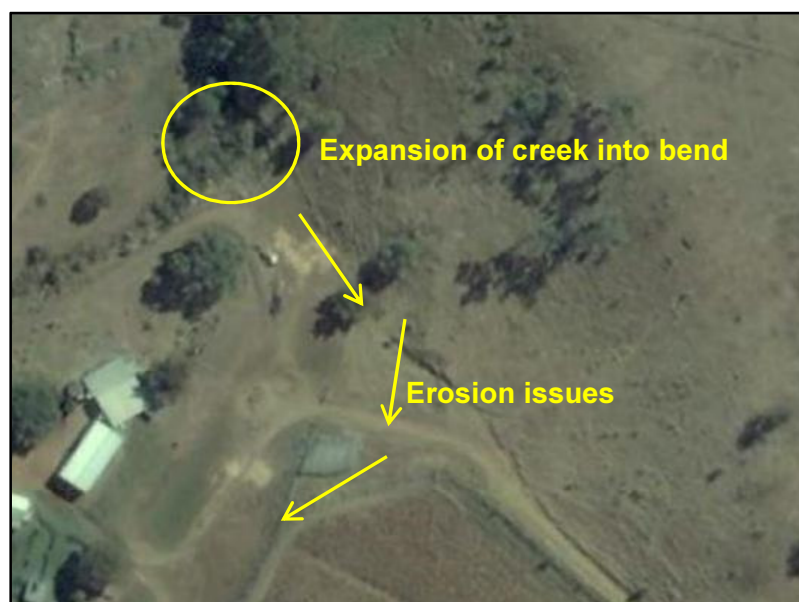
Figure 21 - Expansion of Blackfellow Creek into the bend

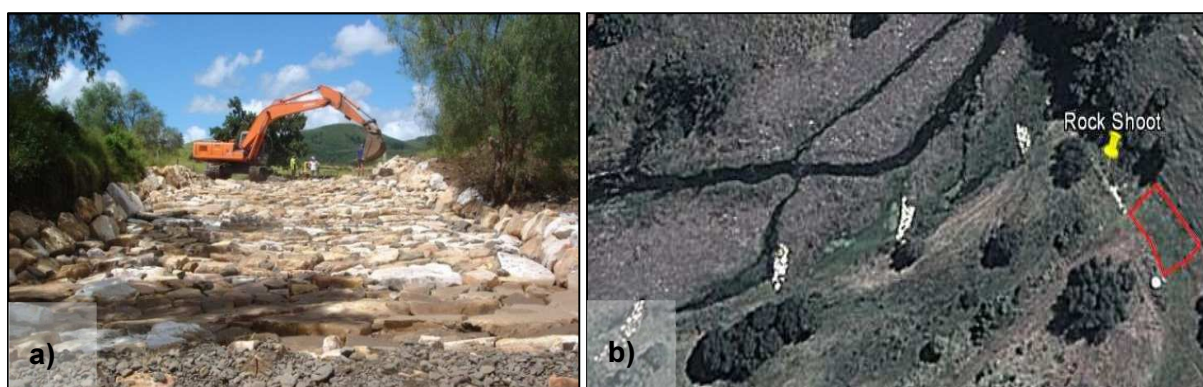
**Figure 23 - Figure a) shows how a large excavator was required to place the last large rocks at the entry point of the rock chute. In figure b) the red boundary indicates the diffuse siltation area before the works**

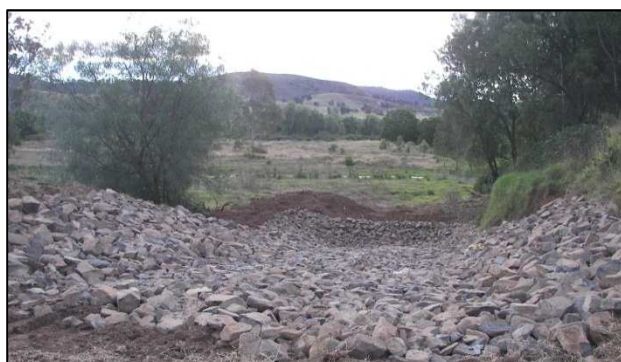
The first attempt at rock chute had an 8 m wide entry and blue metal rocks weighing 20-100kg.

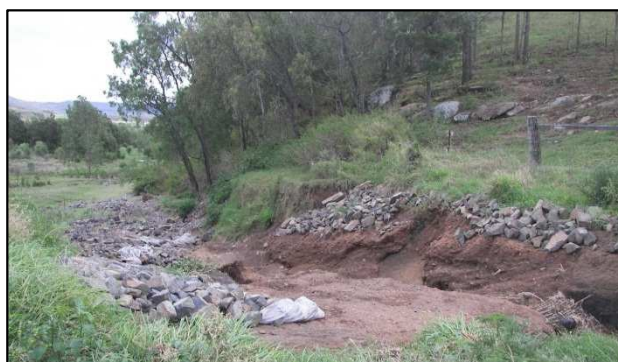
Following 80 ml rainfall on the 6-8<sup>th</sup> November 2009 the rock chute failed and the gully started reforming.

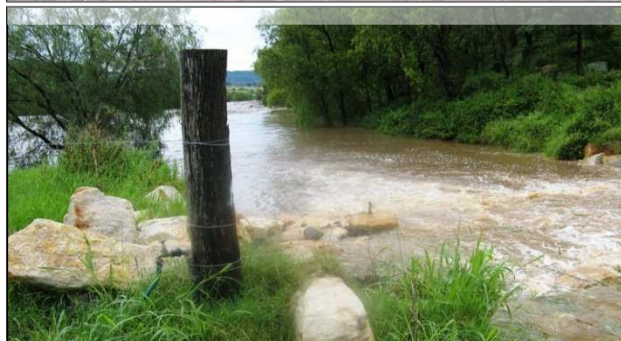
Water spilling over the rock chute after 220 ml of rain from the 10<sup>th</sup> to 12<sup>th</sup> of January 2011.

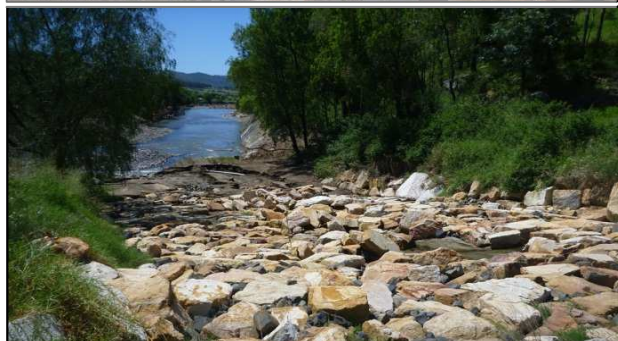
Remarkably the rock chute sustained only minor damage from the January flood, estimated to be over a 1/100 year event.

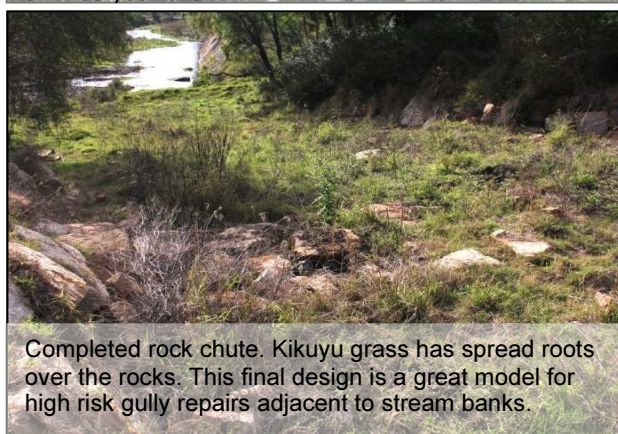
Completed rock chute. Kikuyu grass has spread roots over the rocks. This final design is a great model for high risk gully repairs adjacent to stream banks.

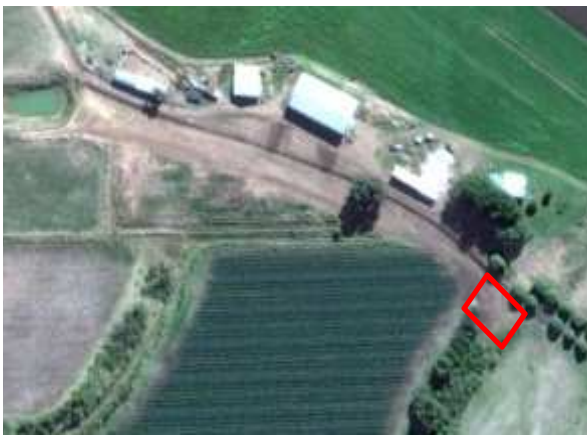
**Figure 26 - Large swale constructed to stop the gully head retreat. The red boundary shows the diffuse siltation monitoring area at the end of the swale**

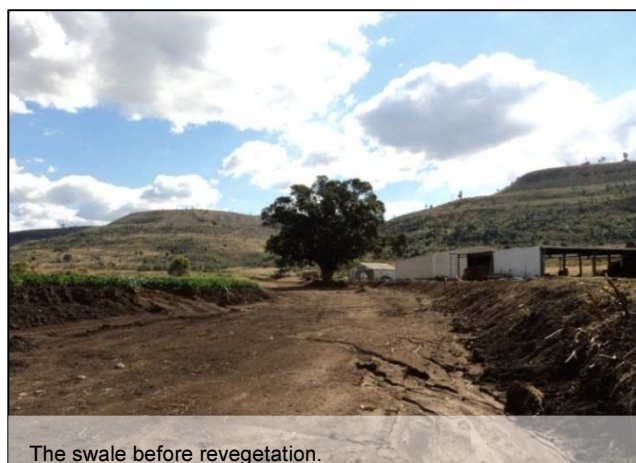
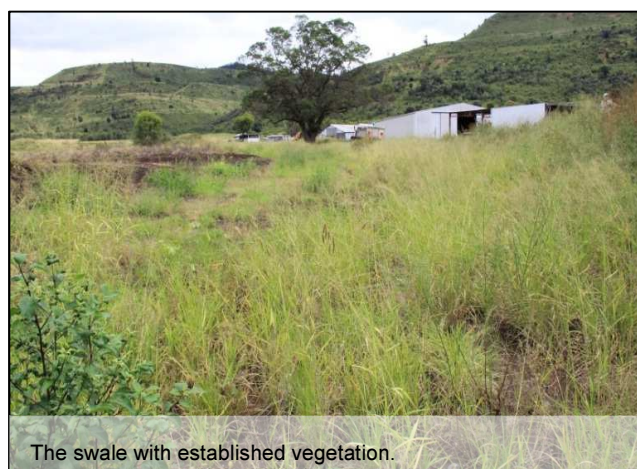
**Figure 27 - Newly excavated swale (a) and subsequent swale revegetation (b and c)**

a) August 2011

c) March 2012

Photographic surveys were undertaken to track the natural regeneration of the grass swale and the stability of the area (Figure 27). Photographic monitoring will be continued to enable the documentation of any weak spots that may appear in the swale, hydrological changes and sediment deposition.

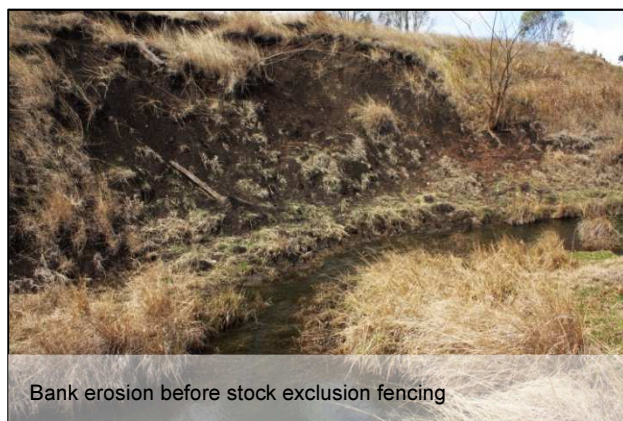
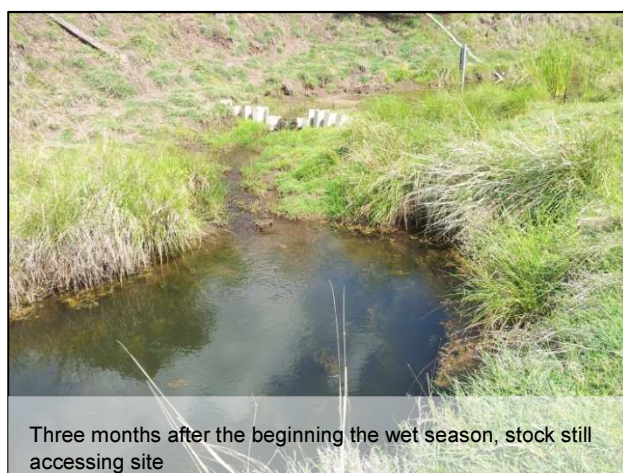
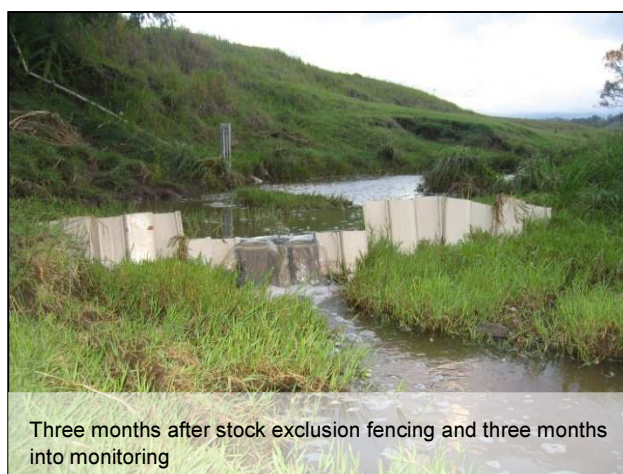
**Figure 35 - Natural revegetation of stream banks following stock exclusion from the creek**

a) August 2011

b) November 2011

c) February 2012

The photographs in Figure 35 show an increase in stream bank vegetation during the monitoring period. To determine if this vegetation remains and is efficient at stabilising the stream bank, photographic monitoring should continue during the dry season.

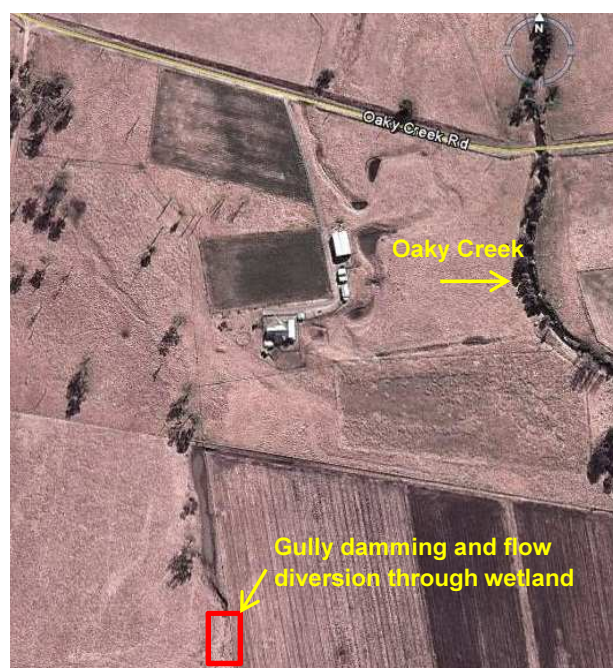
**Figure 38 - Location of dammed gully and area of diffuse siltation monitoring (outlined in red)**
